KODACHROME SLIDES \* REGION 5

Furnished by Harold J. Swan, Head, Regional Current Information Section

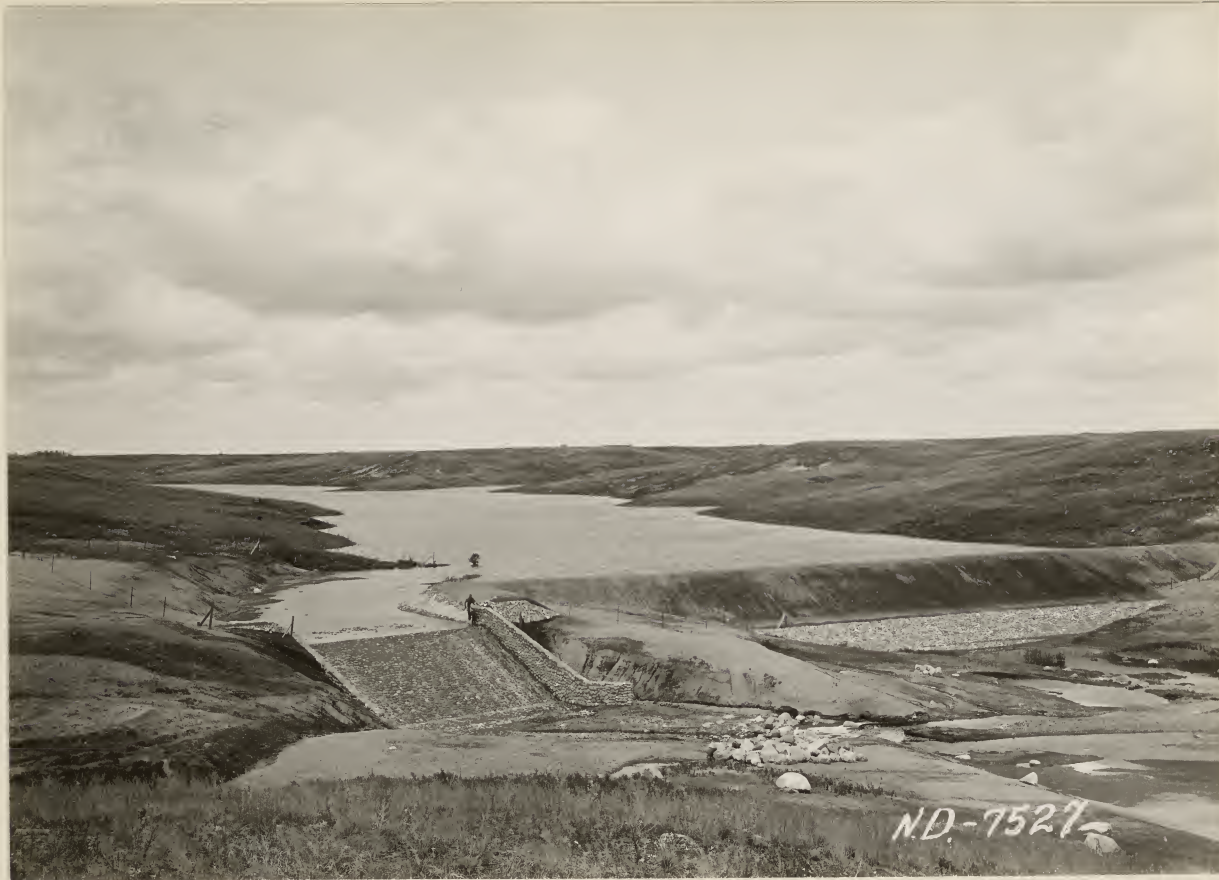
ND-7527. Walsh county. June 9, 1936. Daugherty Dam built in fall and spring of 1935-36 by SCS Camp No. 4. Earth fill with rubble masonry with paved shoot. Reservoir contains 135 acre feet maximum depth 15 feet fill contains 7500 yards.

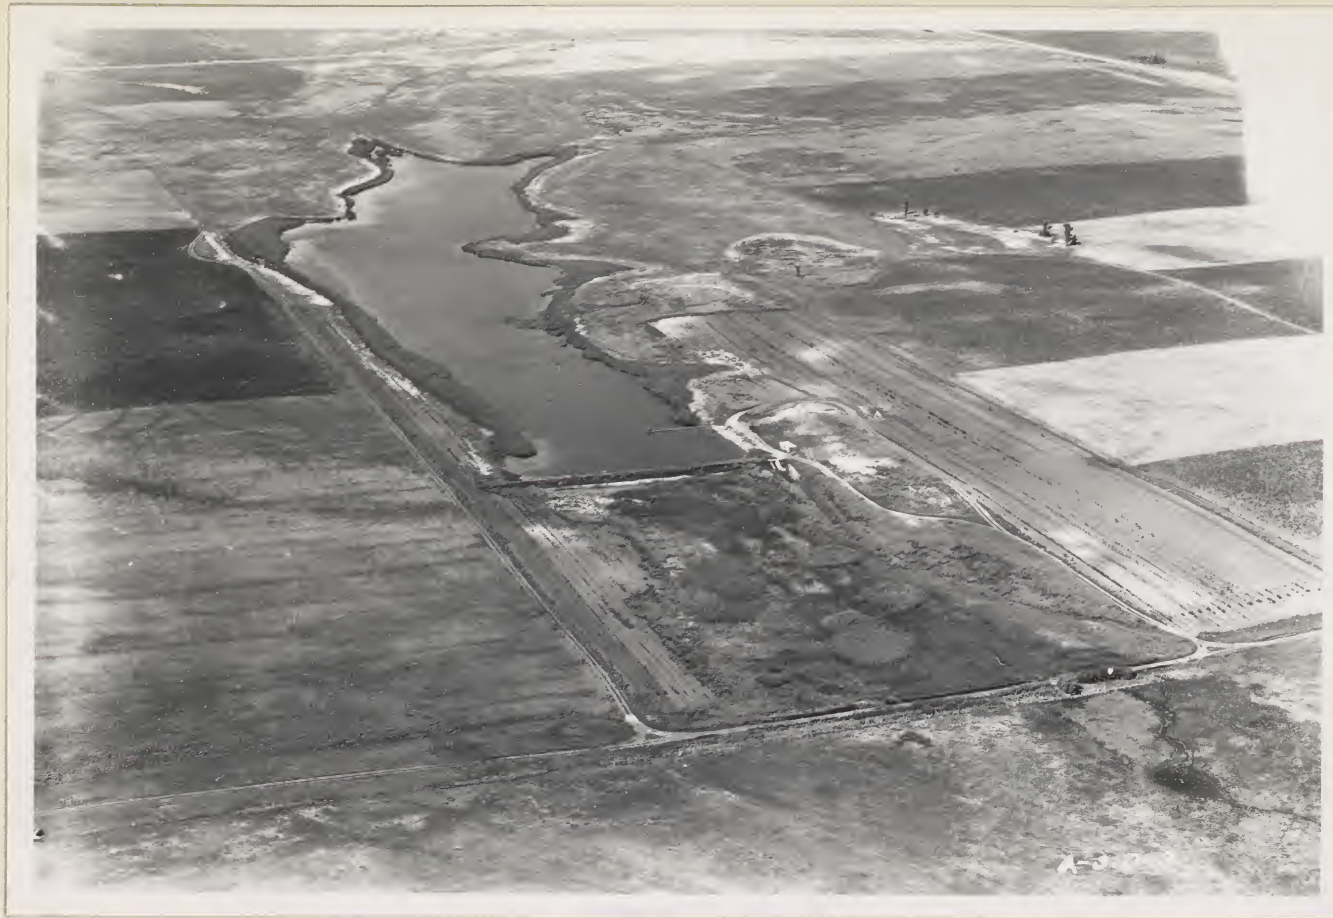
A-SD-3

Constructed in fall of 1935, the Osmanson dam was designed to impound previously wasted water from a large artesian well flowing a stream 8 inches in diameter. 2 windbreaks of trees and shrubs were planted on east and west sides of dam in 1936 to provide wildlife food and shelter as protection from wind erosion to adjoining fields. Fair survival was obtained that year in spite of a severe drought which wiped out most tree plantings on project. 1937 and 1938 replantings met with better success and, when this was taken, there was almost a perfect stand. Native willow and aquatic plants had filled in to make an ideal site for wildlife. A fall, 1938, inventory of dam showed approx. 500 ducks of various species, 300 ring-necked pheasants, 20 black-crowned night herons, 800 red-winged blackbirds, 200 yellow-headed blackbirds, and numerous songbirds were occasional visitors. Partridges, prairie chicken, muskrats, and great blue herons were also seen. In 1937 dam was stocked with crappies and bullheads. SCS improvement operations were credited with this large wildlife population.

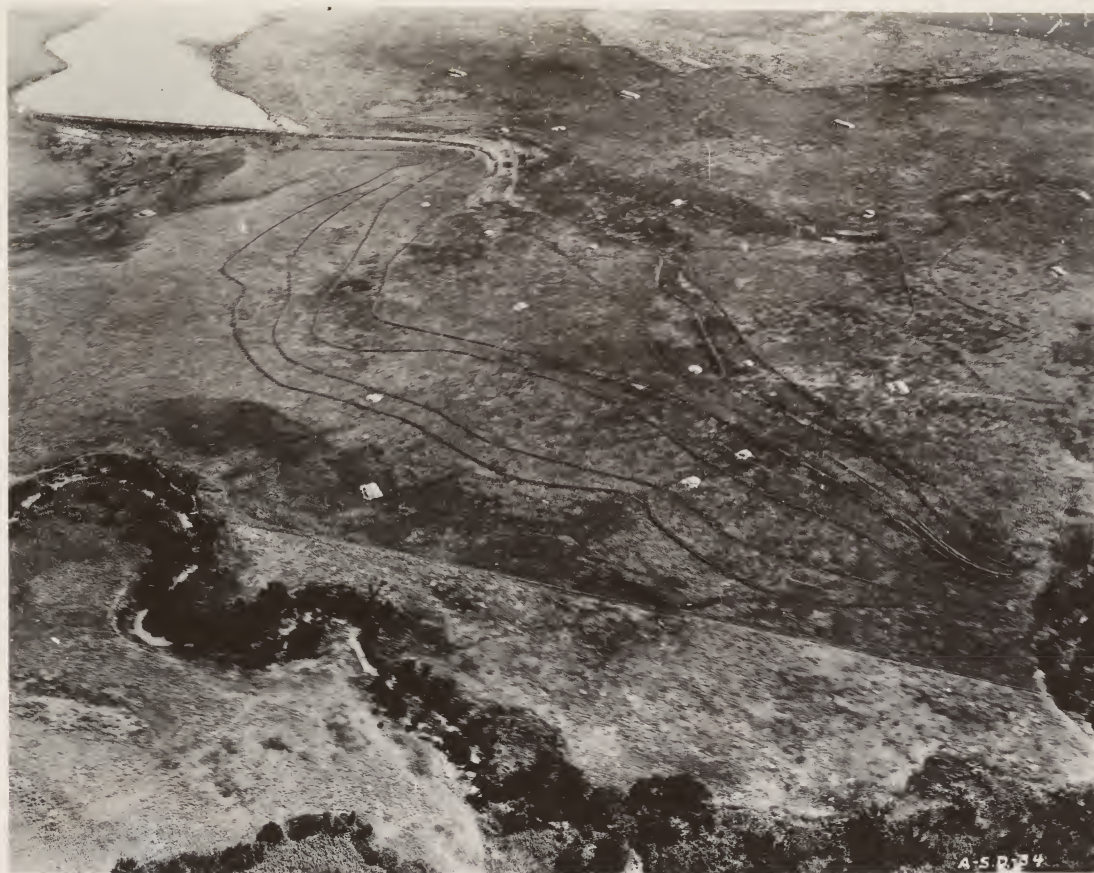
A-SD-34

Spreckles Dam, N $\frac{1}{2}$  of Section 13-R74-T99, Winner-Dixon Soil Conservation Project, Winner, South Dakota. The pasture furrows were used on both sides of this stock watering dam completed June 2, 1937. A system of diversion ditches spread the overflow of water from the spillway over approximately 56 acres of hay land. This dam contained 46.3 acre feet of water, covering an area of 11.5 acres with a maximum depth of 15 feet. It was used for a stock watering dam, servicing about 480 acres of grass land.

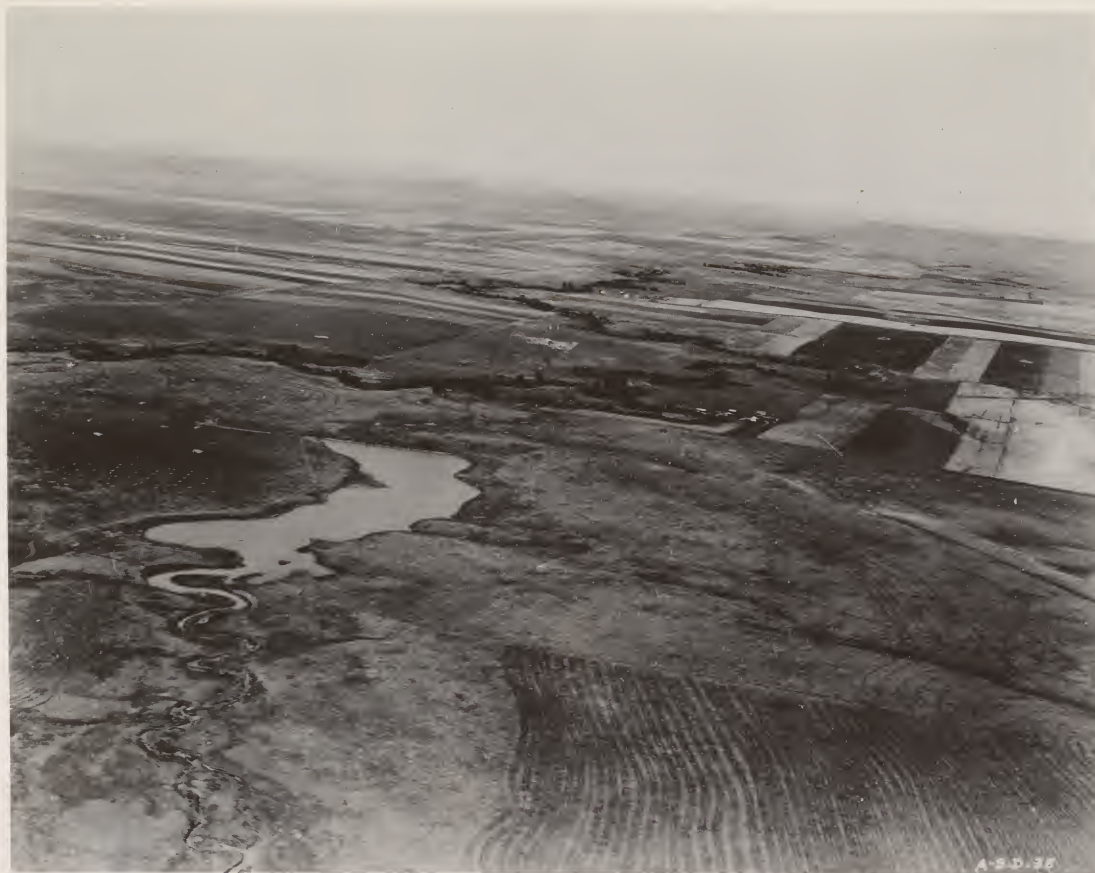
A-SD-35

Spreckles Dam, N $\frac{1}{2}$  of Section 13-R74-T99, Winner-Dixon Soil Conservation Service Project, Winner, South Dakota. These spreader ditches gave excellent results to increasing yields in the native pasture composed chiefly of Western wheatgrass during the crop year of 1938 and the ditches functioned 3 times in 1938 and 4 times in 1939 up to August 1st. A yield of about 1 ton of hay per acre was secured in 1938 as estimated by the hay stacks. This yield is approximately 50 per cent greater than that on similar not-flood-irrigated land. The 1939 crop would no doubt exceed the yield for 1938.

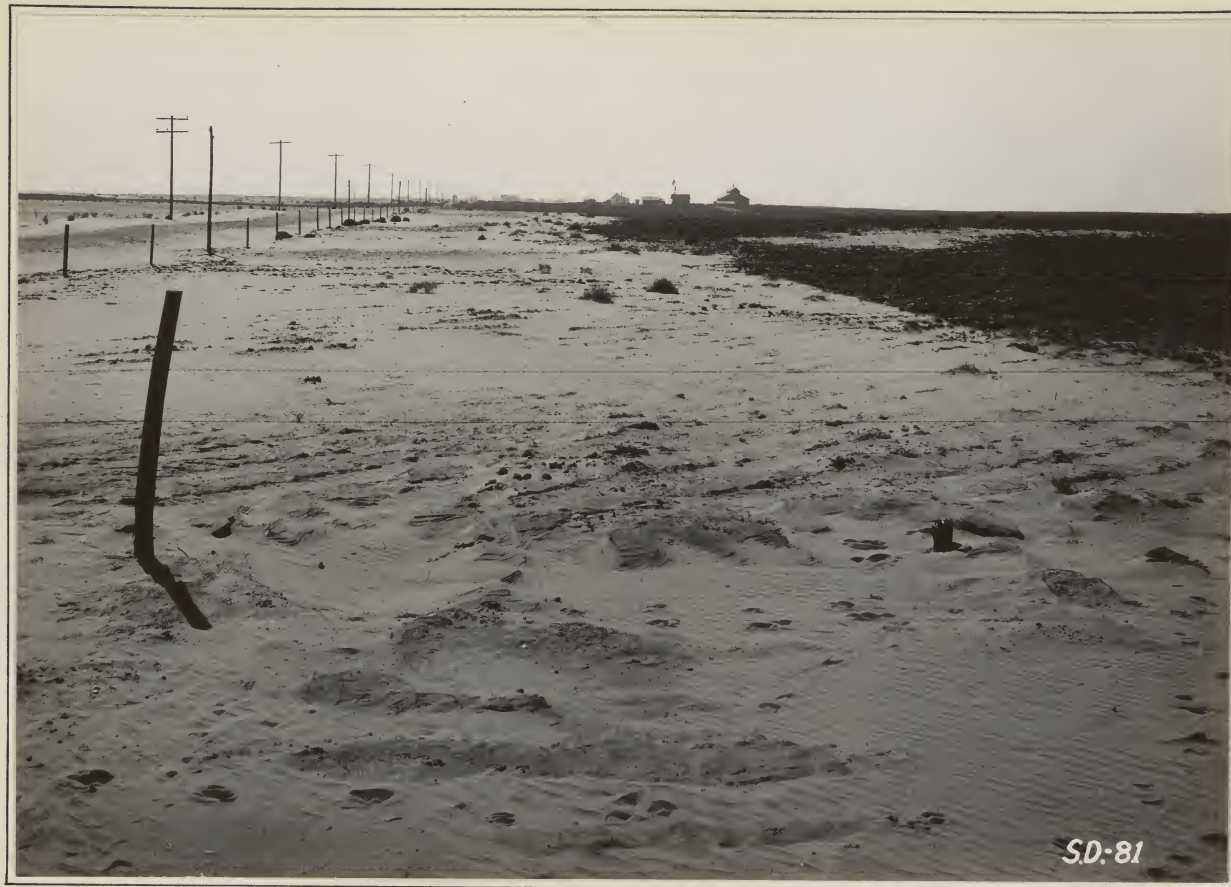
SD-81 - South Dakota  
EROSION - Wind

Soil drifted in from a neighboring non-cooperative farm onto the Stegeman farm, filling in the listed furrows for an average distance of 80 feet from the fence. October 19, 1935

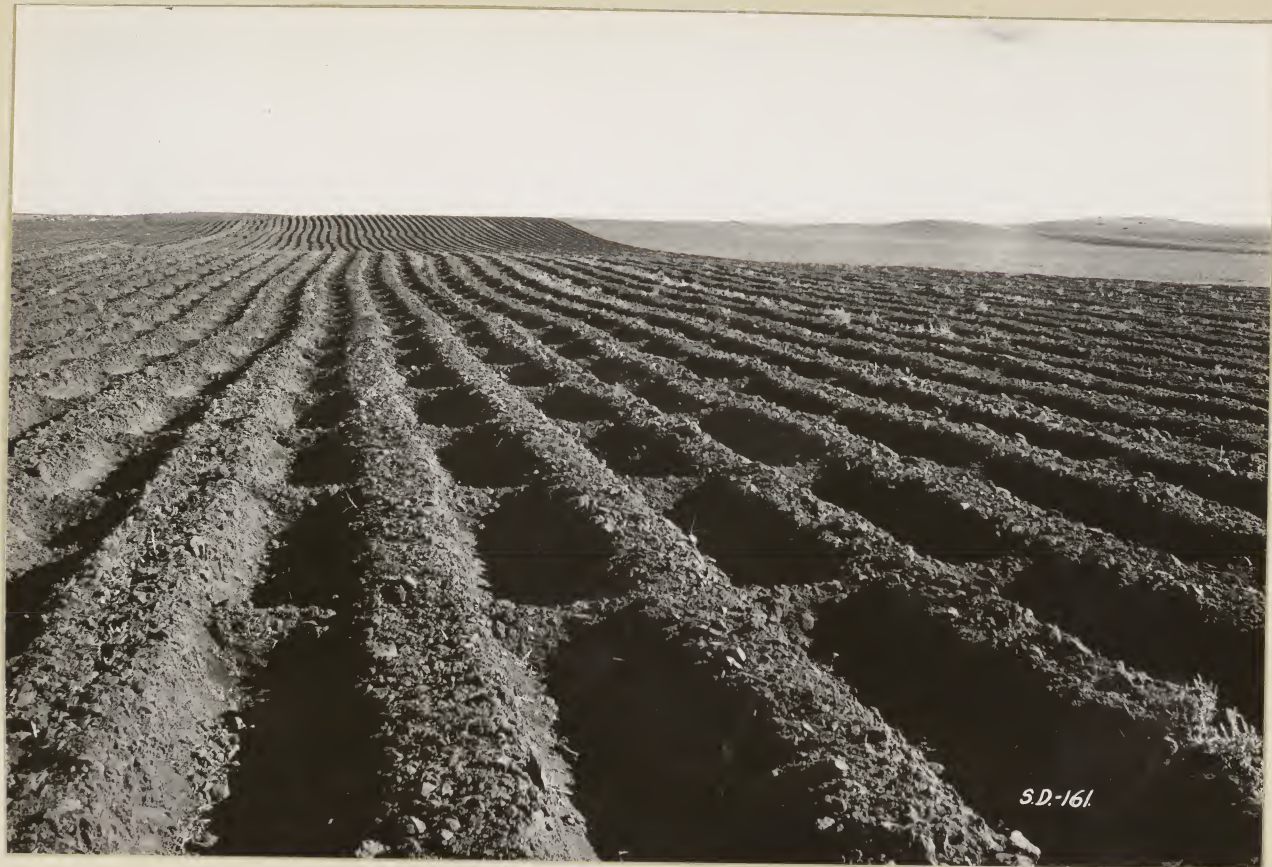
SD-161. Beadle County, South Dakota; 11-27-36.

Basin Listing:- About ten acres of this 33 acre field were basin listed. The original plan was to ordinary list a similar area and the remainder was to be left untreated. This field is representative of many fields in this section. The land here is fairly rolling and will give an opportunity for studying moisture penetration on a number of different slopes. The distance between the dams in the listed furrows is about ten feet and the average height is from 6 to 8 inches. No part of this field was listed on the contour since the cooperator was not interested in contour farming at the time the work was done. Some row crop, probably corn will be planted next spring. It is likely that the fall listed land will be middle-busted in the spring. The chief advantage of basin listing above that of ordinary listing is that it profices a means of moisture conservation. The object of this experiment is to try out basin listing, ordinary listing, and the method which the cooperator intends using next spring side by side.

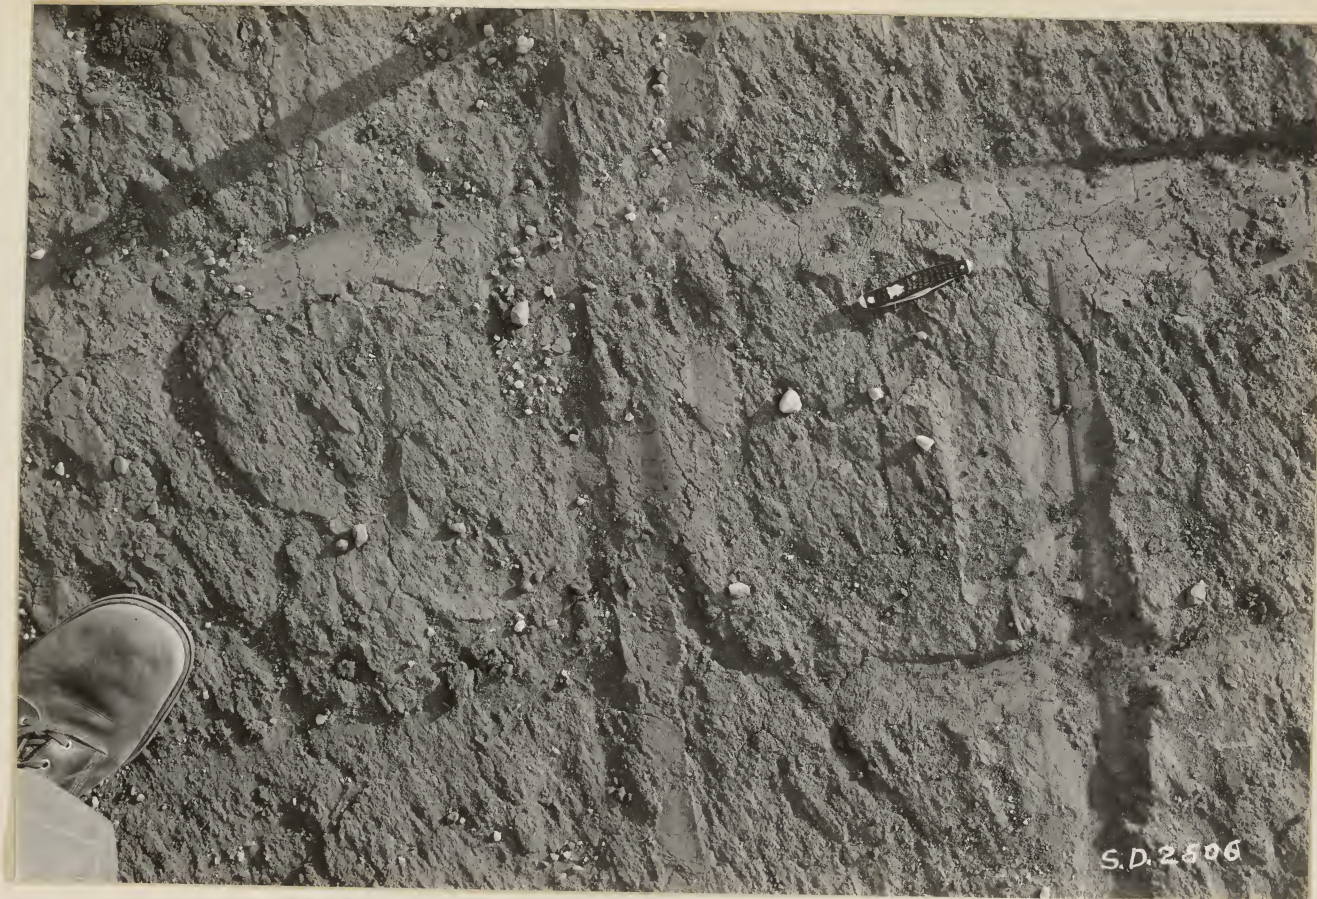
SD-2506 - South Dakota.  
EROSION - Wind.

Close up of a couple of squares made by the plow marks in the subsoil, which has been exposed by blowing.

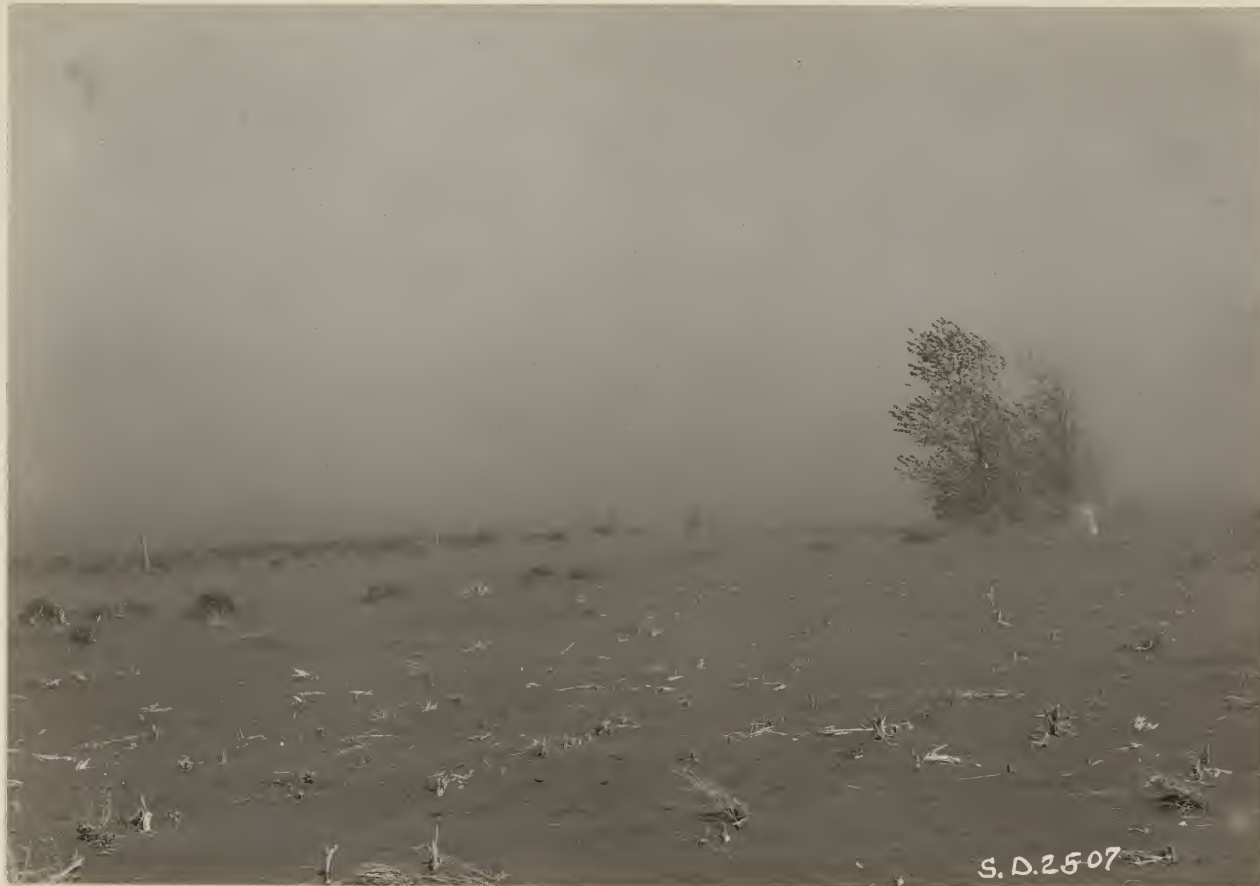
SD 2507 - South Dakota, Beadle Co, Oct 15 1935

The soil in this cornfield, which had been cut, is blowing out. Rye has been seeded in this field, but hasn't had the proper start because of lack of rainfall and is also being blown out. The adjoining field in which the corn is not cut, is not blowing out. The wind velocity when the picture was taken was about 26 M.P.H.

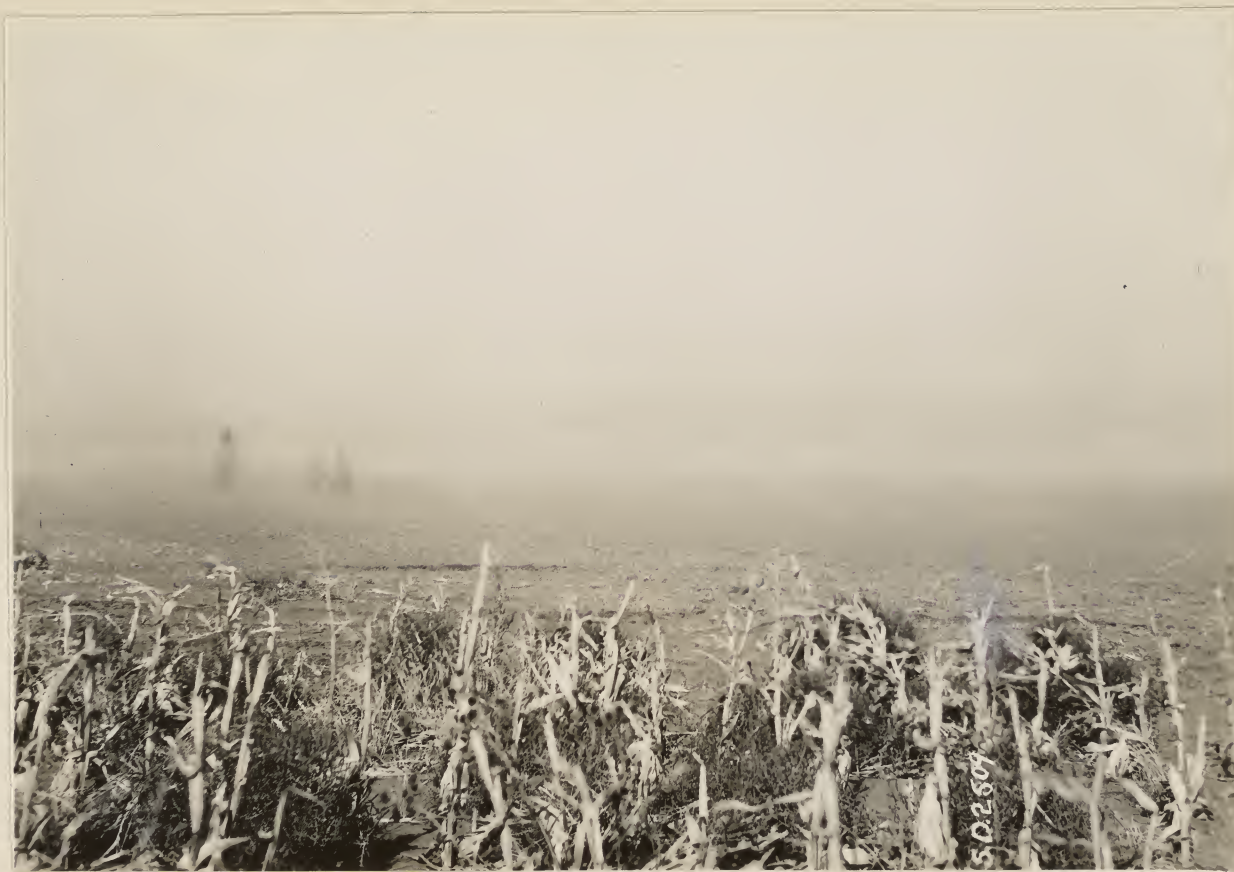
SD-2509 - South Dakota.  
EROSION - Wind.

Cut and uncut corn in the same quarter section as preceding picture. The soil in the cut-section (background) is unprotected and is blowing out rapidly. The soil in the uncut section (foreground) is protected and not being blown out. The wind velocity when this picture was taken was about 26 M.P.H.

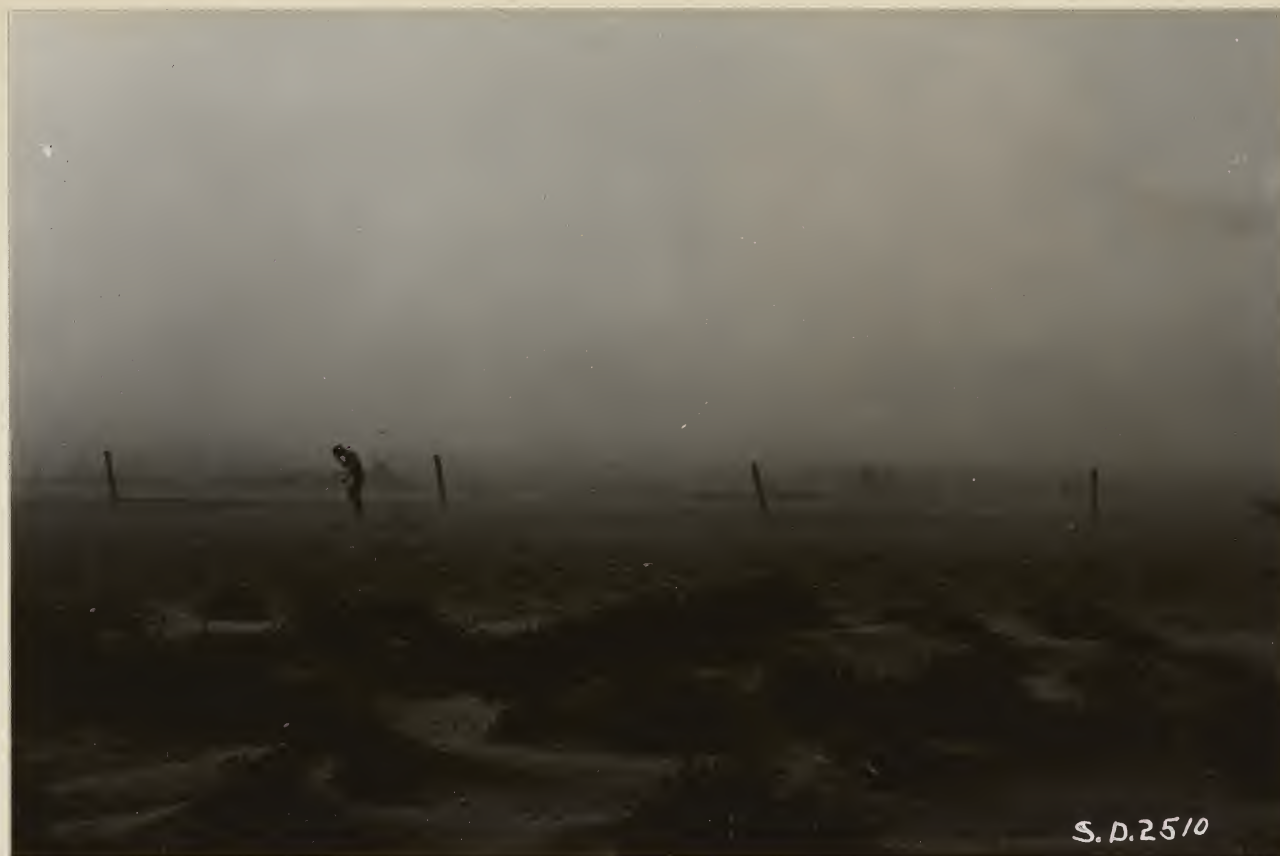
SD-2510. Beadle County, South Dakota; 10-15-35.

Fence row drifts blowing out again parallel with fence. Russian thistles also blowing. Human figure (Caird) going south into the wind. The velocity of the wind is about 26 M.P.H. Small drifts can be seen in the foreground of the picture, showing the formation on the protected side of each Russian thistle.

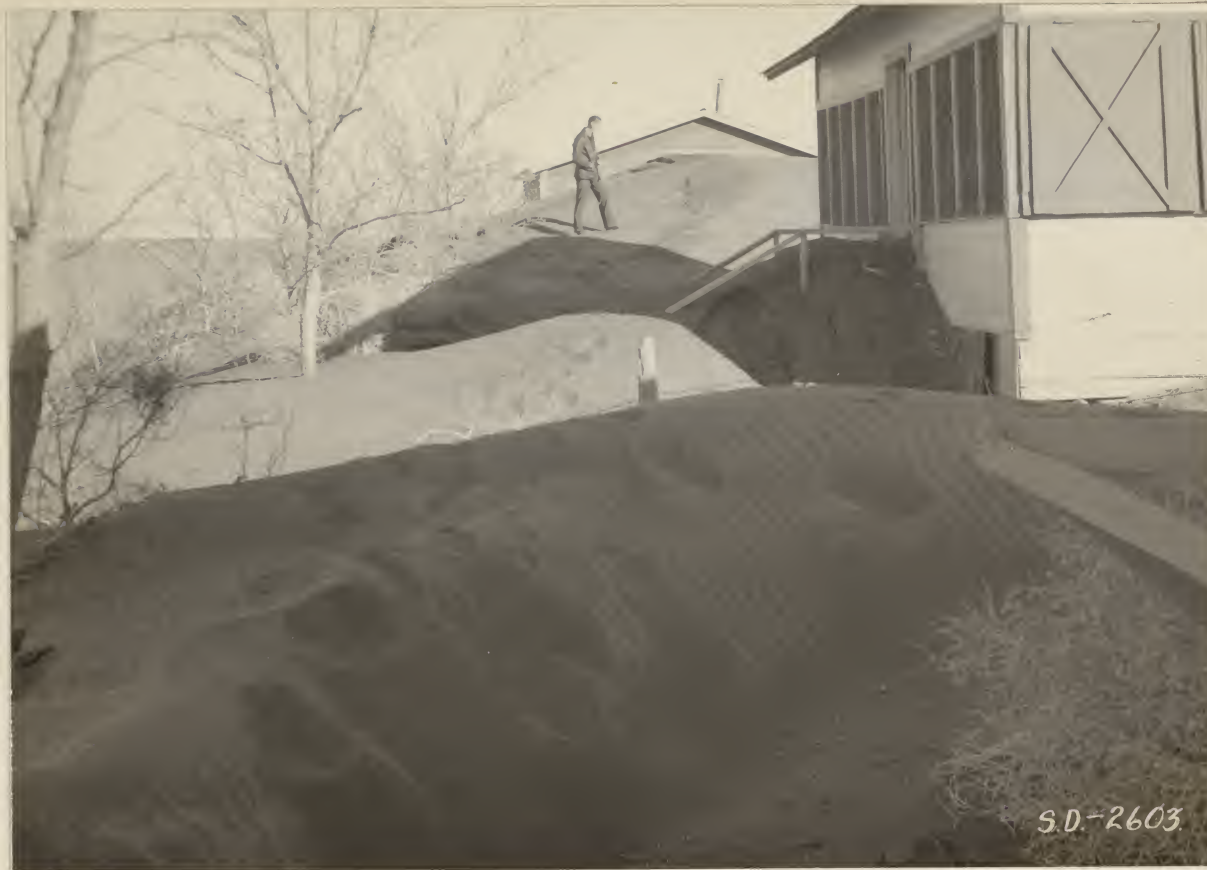
SD-2603. South Dakota.  
EROSION - WIND.

Dust drifts along the south side of Lake Byron. Largest dust drifts about 10 feet high. Scott McMichael on dust bank to show relative size.

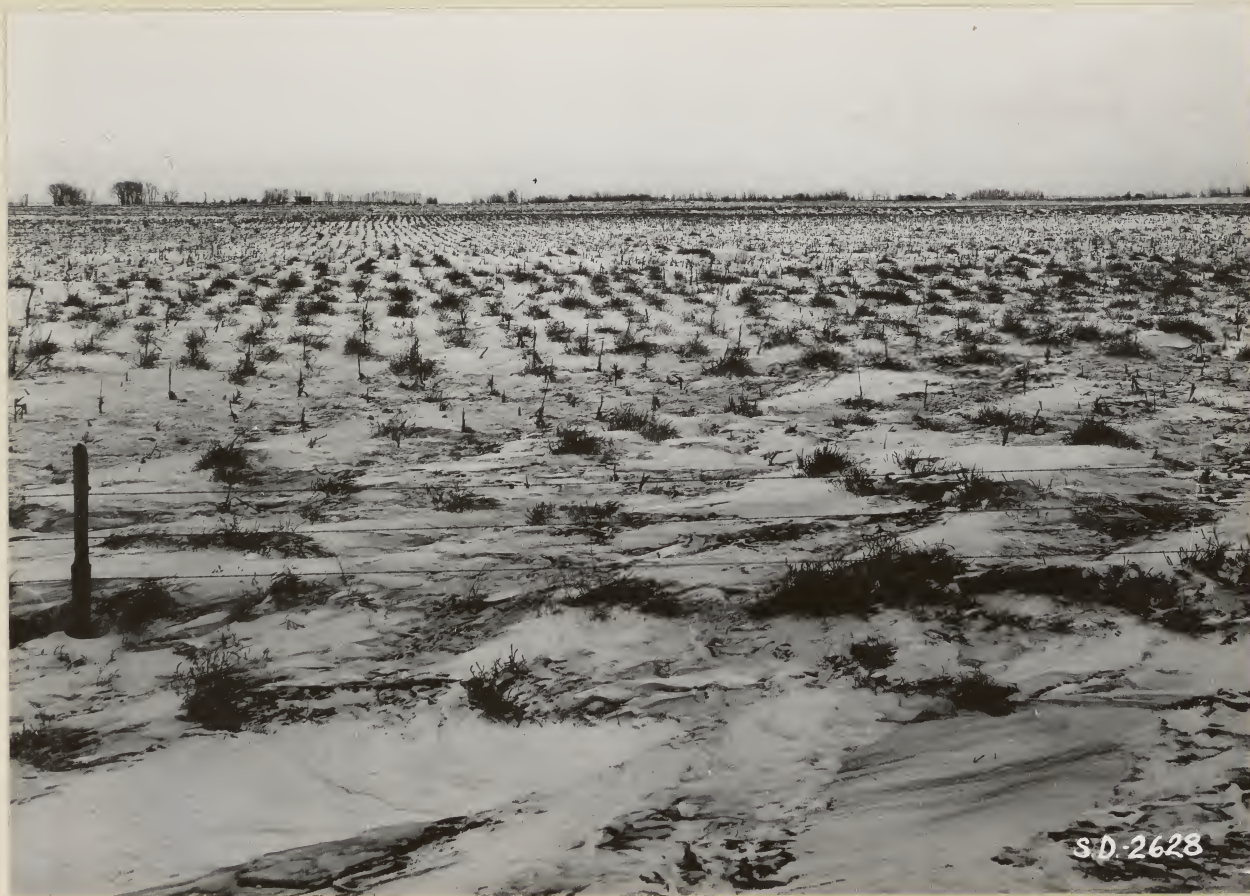
SD-2628. Beadle County, South Dakota; 2-19-36.

Corn field-filled in by snow. The corn was cut in the fall. The short stalks and weeds, such as Russian thistles have stopped considerable snow.

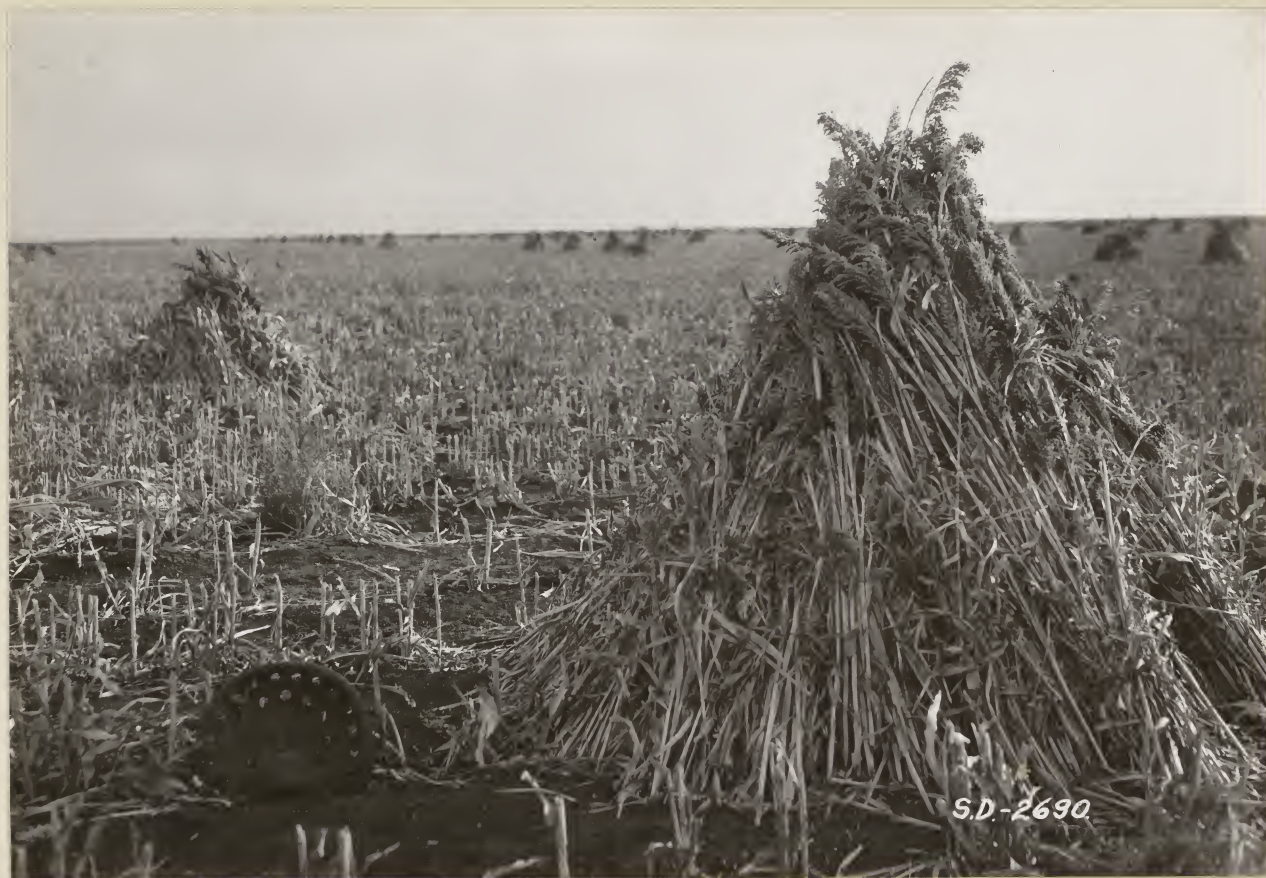
SD-2690. Beadle County, South Dakota; 10-3-36.

This field was seeded in cane. The cane has been cut and shocked. The old seat from farm implement serves to illustrate the size of shock and height of the stubble left to protect the field from blowing. The cane was planted on listed blow land drilled in listed furrows in June. This same field is shown in SD-2685.

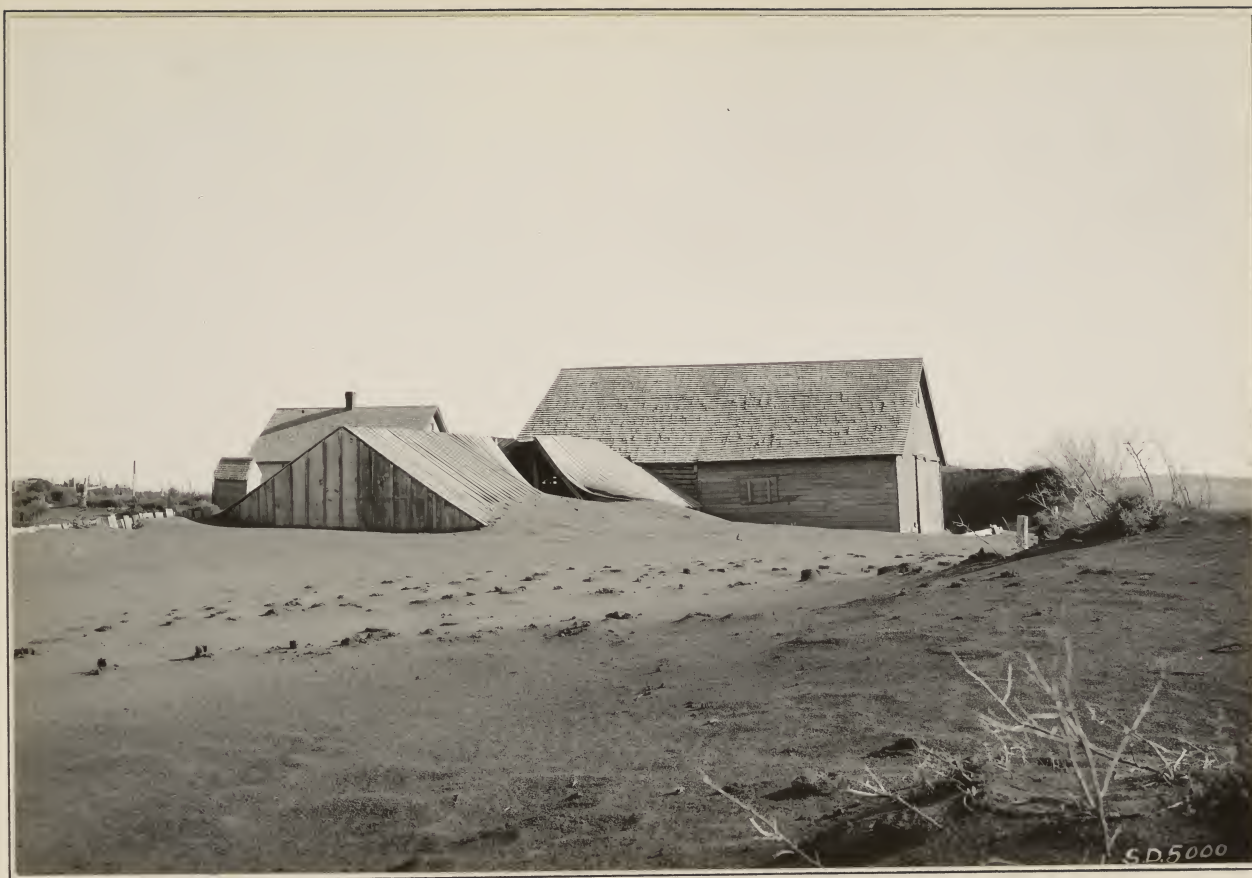
SD-5000 - South Dakota  
EROSION - Wind

View of back of farm buildings, showing dust piled up on one of them, which has been caved in by the weight of the drifts. The house is still furnished but not in use.

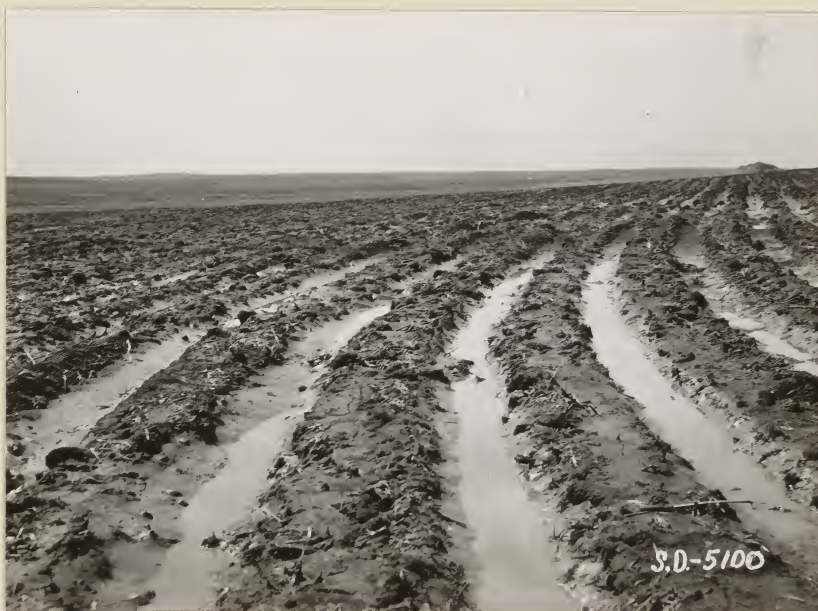
Water impounded in contour furrows 20 hours after 2.25 inch rain.

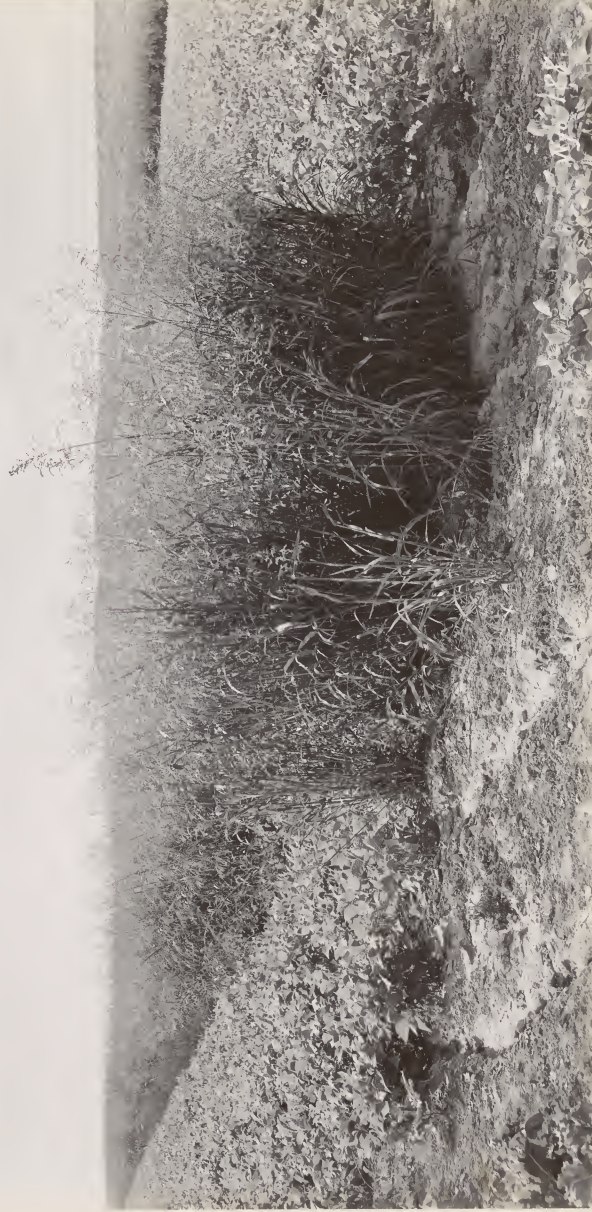
Wyo-138

Strips of tall-growing Sudan grass like this one on the E. C. Brines farm 13 miles northwest of Riverton, were planted in 1937 in cooperation with the Lander SCS project for fall and winter protection of adjacent soil against wind blowing. The Sudan strips were six feet wide, between 100-foot strips of sugar beets. In the irrigated district, this field was in beans in 1936 and planned for corn in 1938.

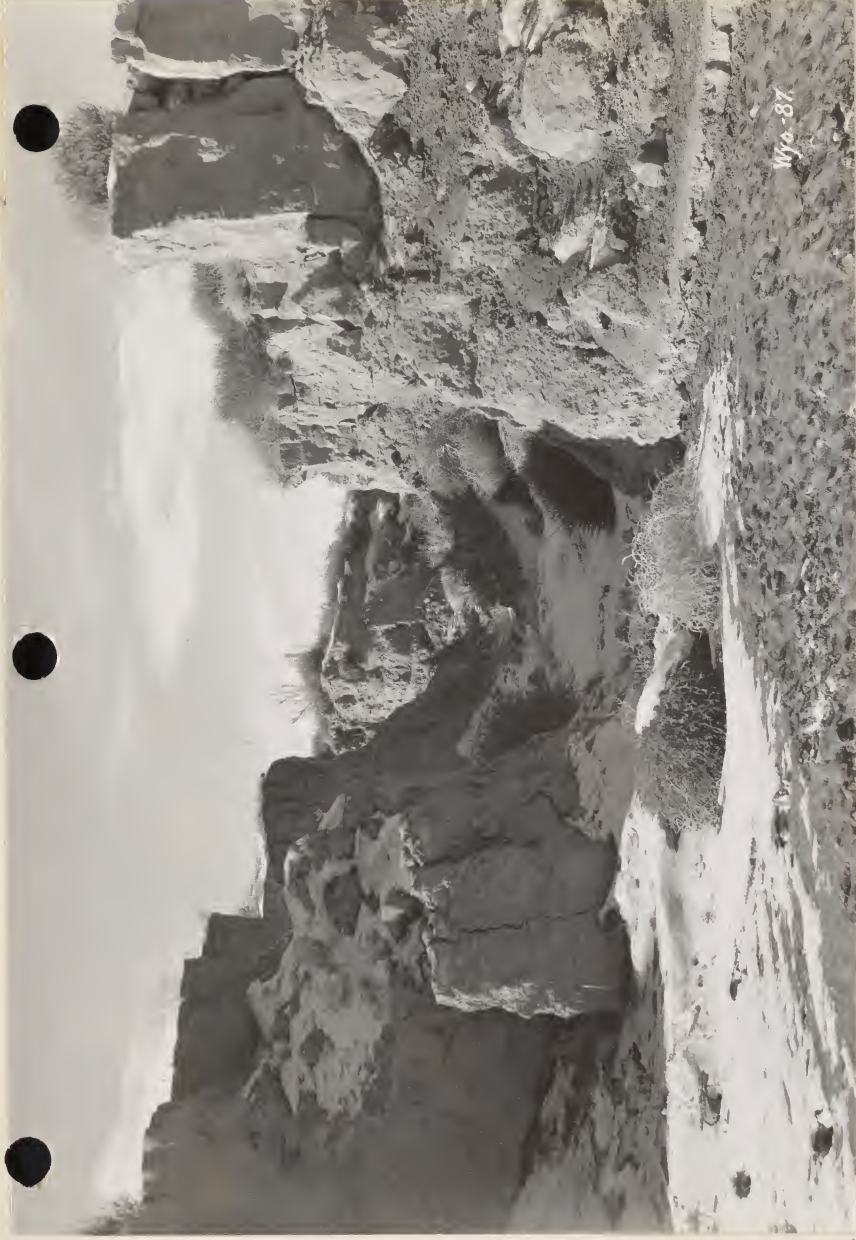
Wyo-87

Looking up a gully that has been cut from an irrigation ditch due to improper control of irrigation water. This picture was made from the bottom of the main gully which is approximately 50 feet wide. About 20 acres of the 80-acre farm have been destroyed in this way in the past two years. This is on one of the Resettlement farms in this area.

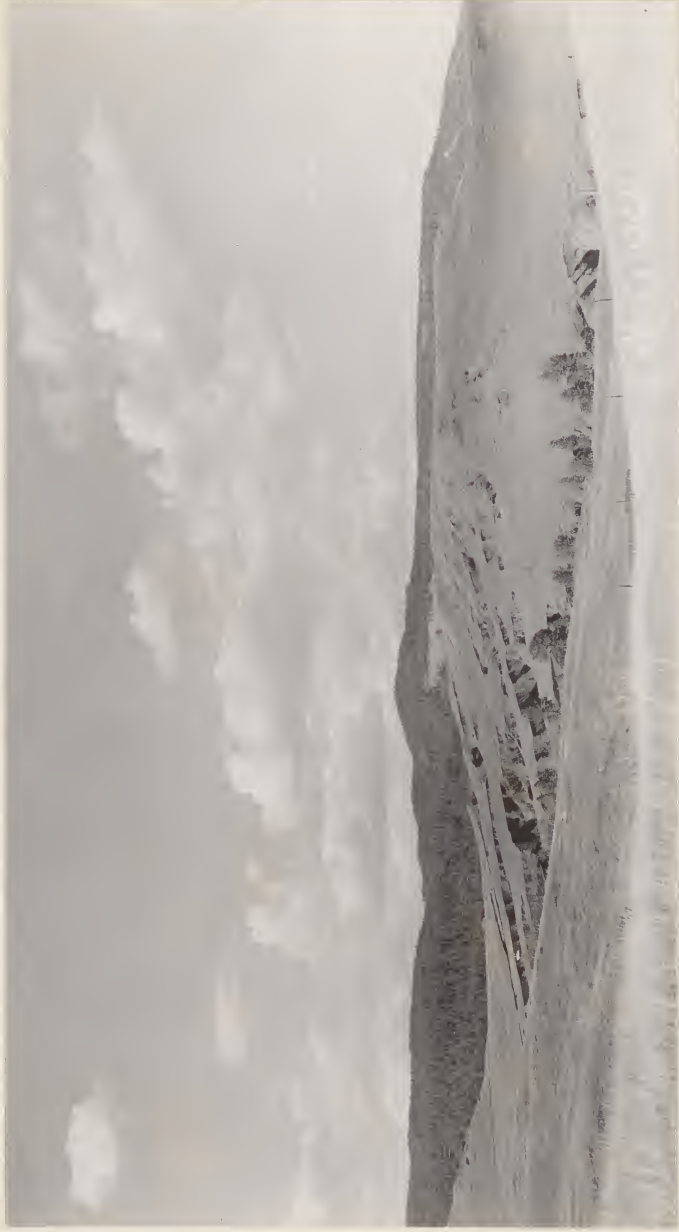
Wyo-10001

Badly water-eroded hill. The land in this region is very badly eroded, gullies and sheet erosion.

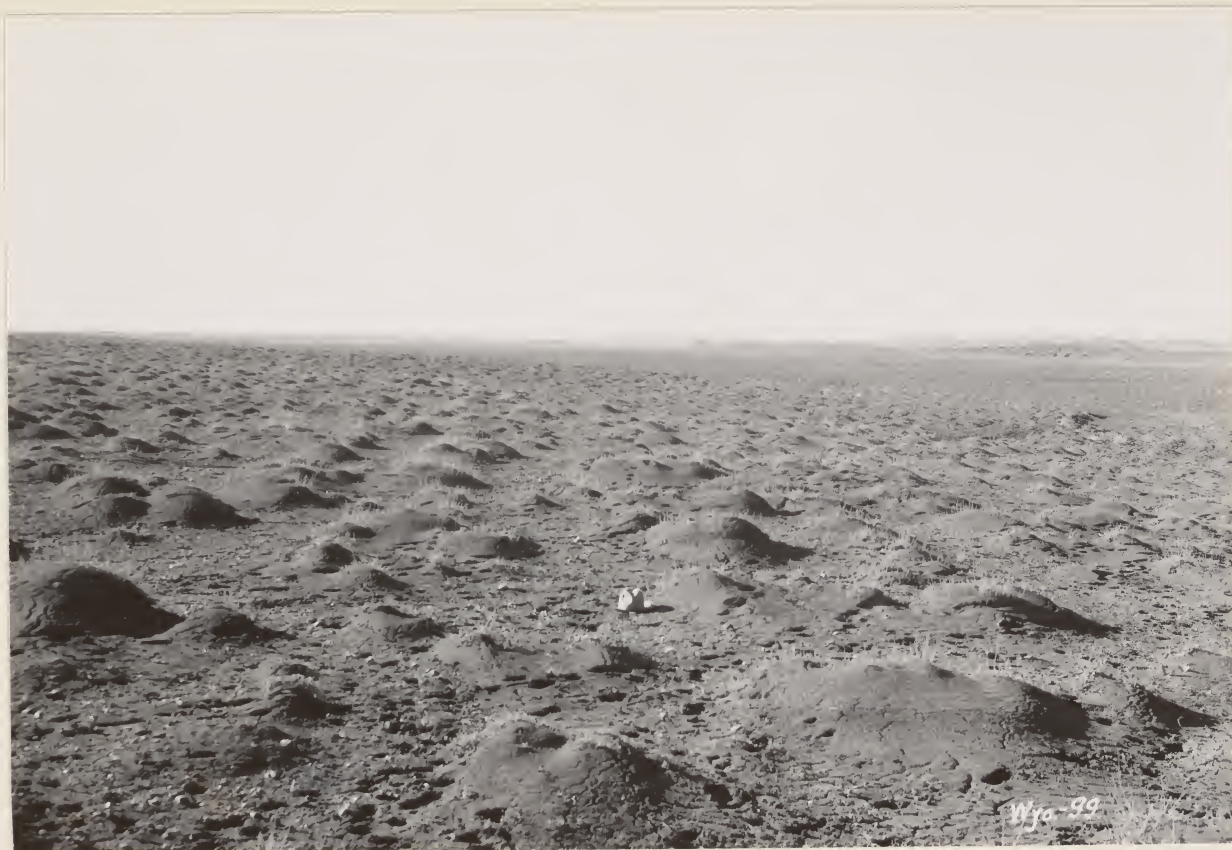
Wyo-99

This view shows how wind erosion is building hummocks around the salt sage. No control work was planned for the field, but it was under observation to show what has happened over a period of time when no control is practiced. Photo Station No. 3.

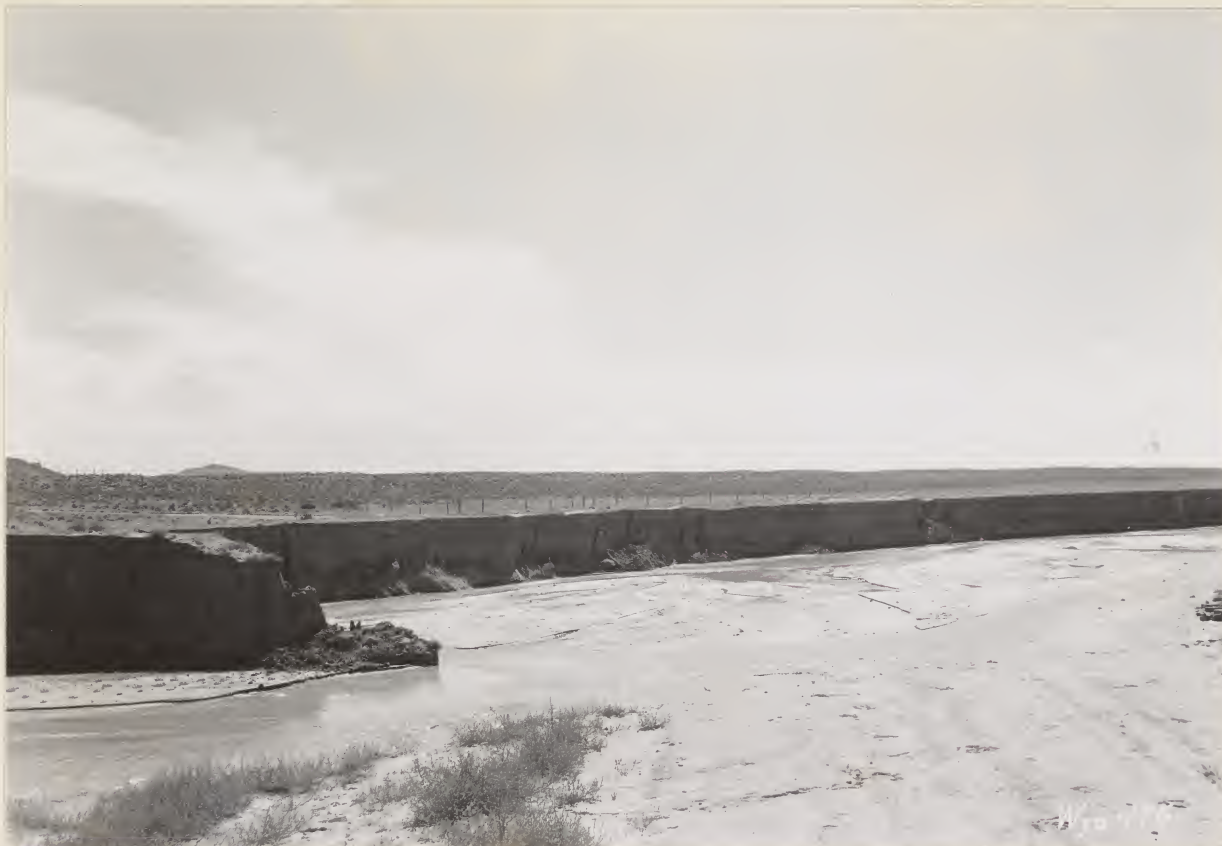
Wyo-176

The effects of erosion under flood conditions are indicated by this picture, taken on Teapot Creek, four miles west of Shoshoni, in late August, 1937. Spring floods and excess irrigation drainage had widened this stream channel to approximately 100 feet; whereas a 30-foot bridge spanned it at this point until the 1937 season.
